## 4 Structural Performance

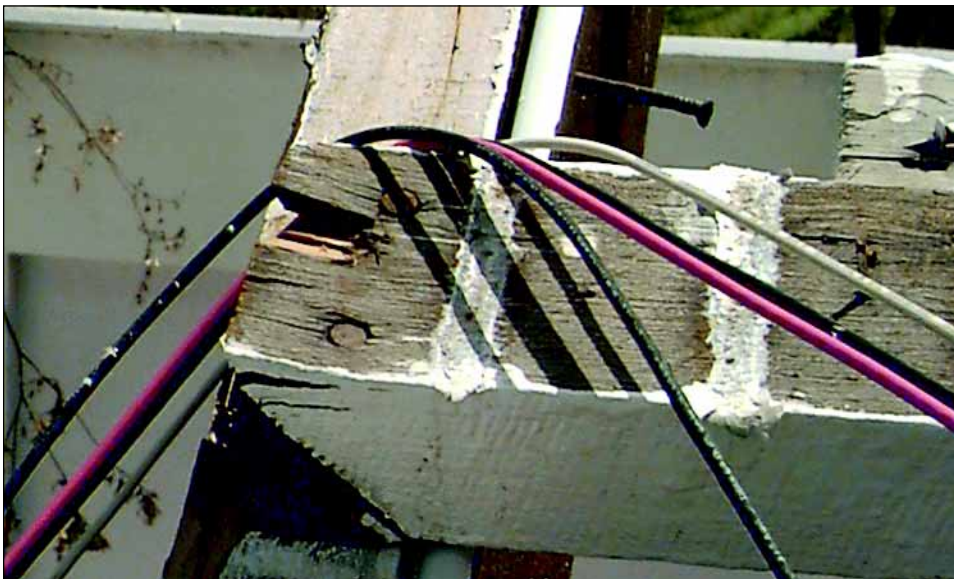
**FIGURE 4-10** Nailed roof structure connection from church in Figure 4-9.

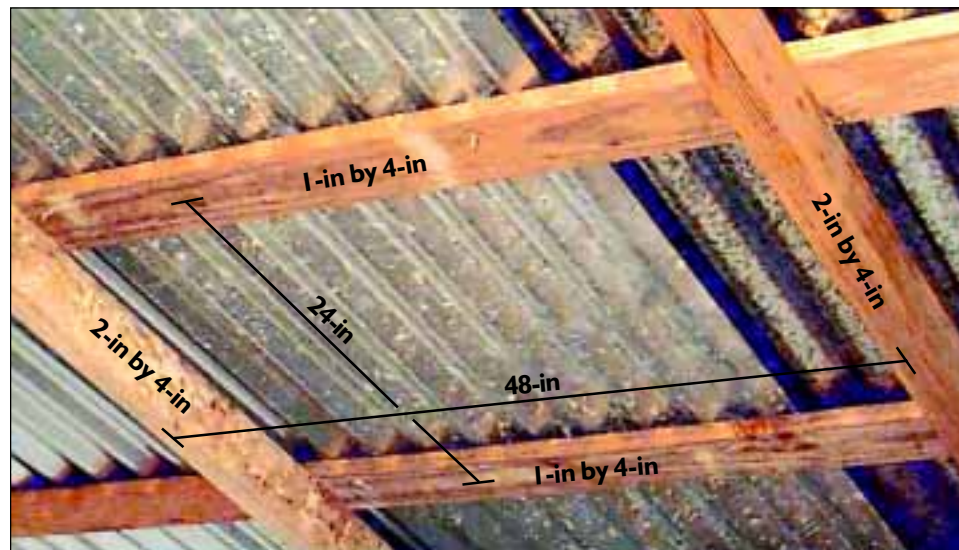
**FIGURE 4-16** Typical wooden roof structure with metal roof panels above. Nails connected the metal panels to the nailers and the nailers were nailed to the joists.

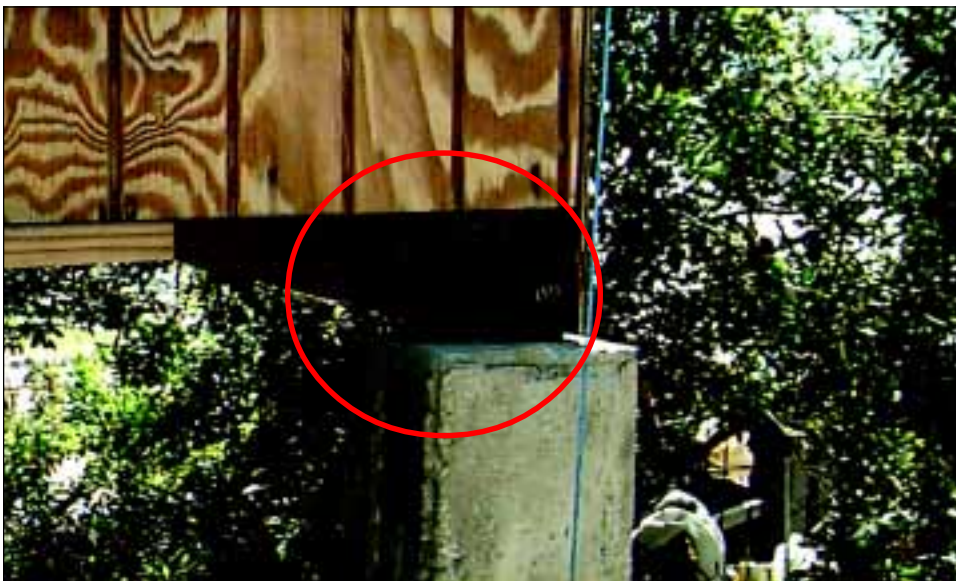
**FIGURE 4-18** Example of a non-engineered connection between the building foundation (concrete column) and the floor system. The wooden floor beam is connected to foundation rebar with an improper nailed connection.

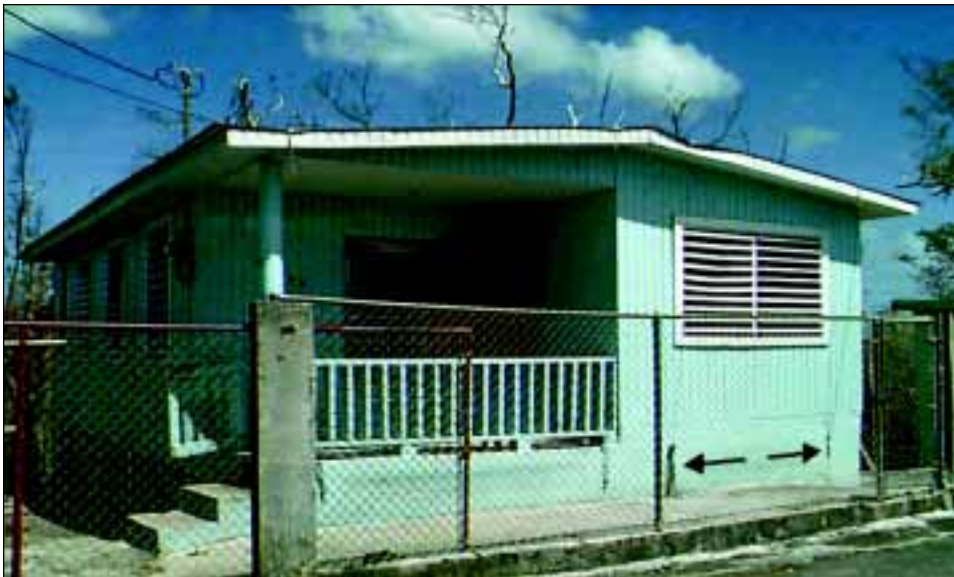
**FIGURE 4-21** Wood-frame house with metal roof covering with hold-down cables that run parallel (see arrows) and perpendicular to the roof ridge line. This house was set atop a ridge that experienced significant winds. The lack of damage can be attributed to the extra care taken in fastening down the corrugated metal roofing. The strapping would not have prevented buckling of the roofing or uplift at the eave.

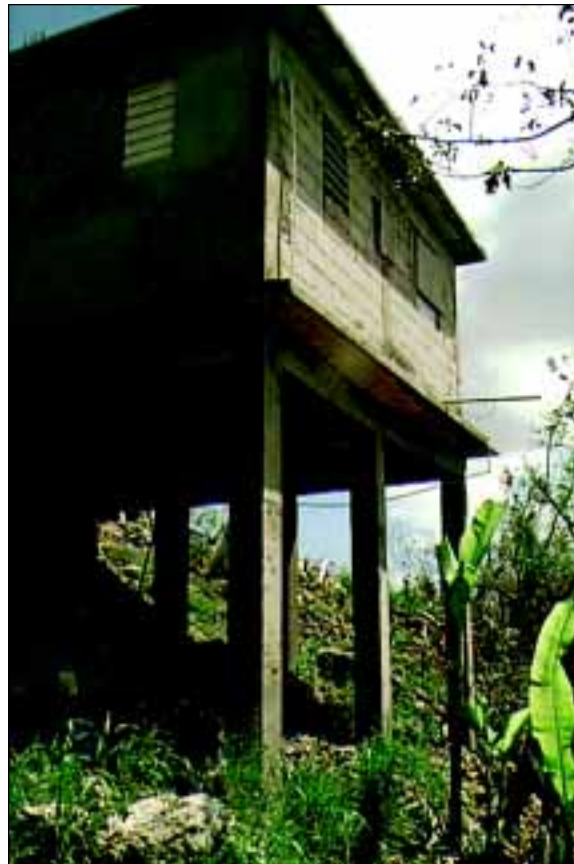
**FIGURE 4-22** Residential building supported atop tall, unbraced concrete columns. This type of unbraced support column was common in many areas.

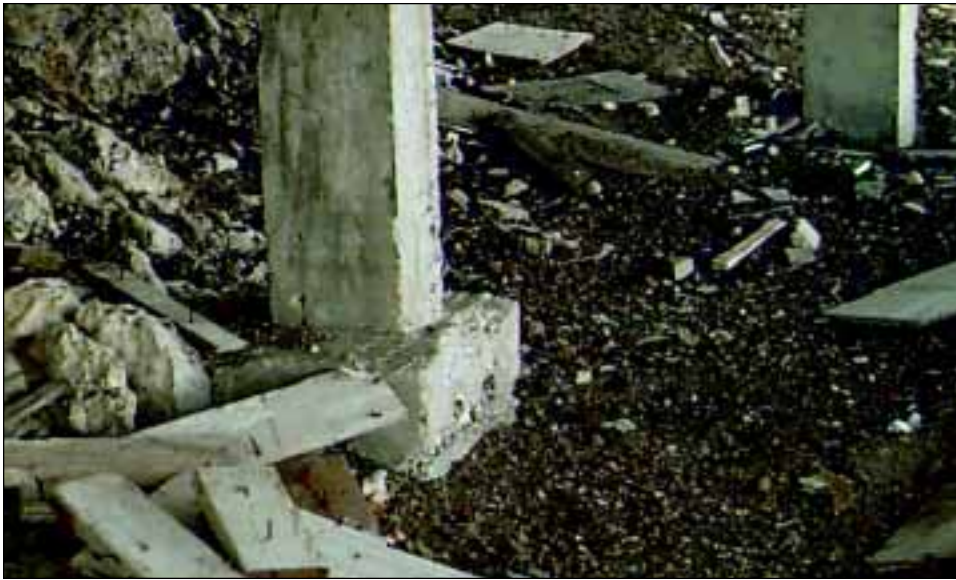
**FIGURE 4-23** Footing for tall columns in Figure 4-22. This footing is not adequately anchored to the supporting rock to resist lateral forces that may be induced during a design seismic event.
